FHWA/IN/JTRP-99/4

Final Report

**EMBANKMENT WIDENING DESIGN GUIDELINES
AND CONSTRUCTION PROCEDURES**

September 1999

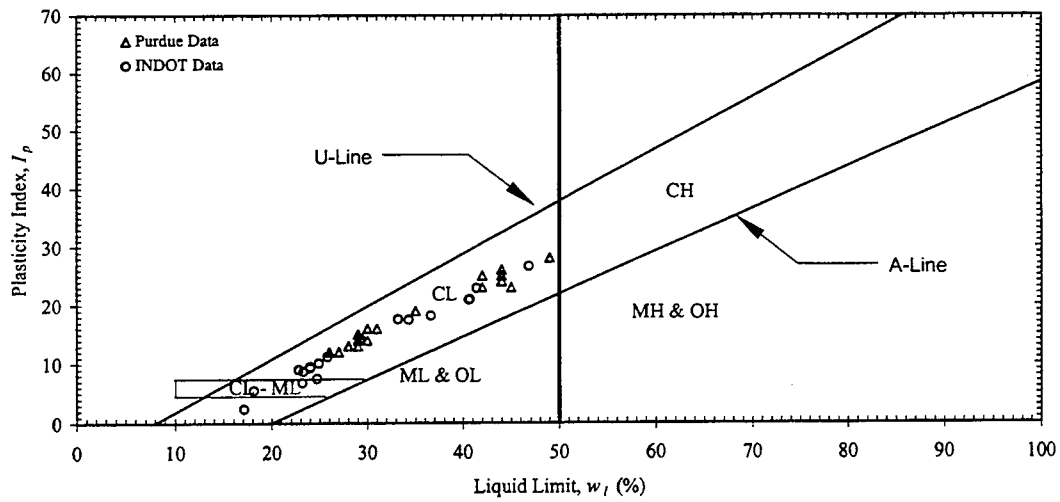
Figure 4.2. Atterberg limits data, I-69, Madison County, Greenfield District.

A post-failure investigation was performed by INDOT. The field work was performed between December 1994 and March 1995. As part of this investigation seven borings were advanced and split-barrel samples were collected. Index tests, including grain size distribution, hydrometer and Atterberg limits analyses were performed on select split-barrel samples. The index test data has been summarized in Figures 4.2 and 4.3. As indicated by the index test data, the soils in the original embankment and those used to steepen the sideslopes are primarily low plasticity, fine grained soils, classified as CL in accordance with the Unified Soil Classification System. The activity, *A*, of these soils is approximately 0.75 on average, indicating that illite is the primary clay mineral.

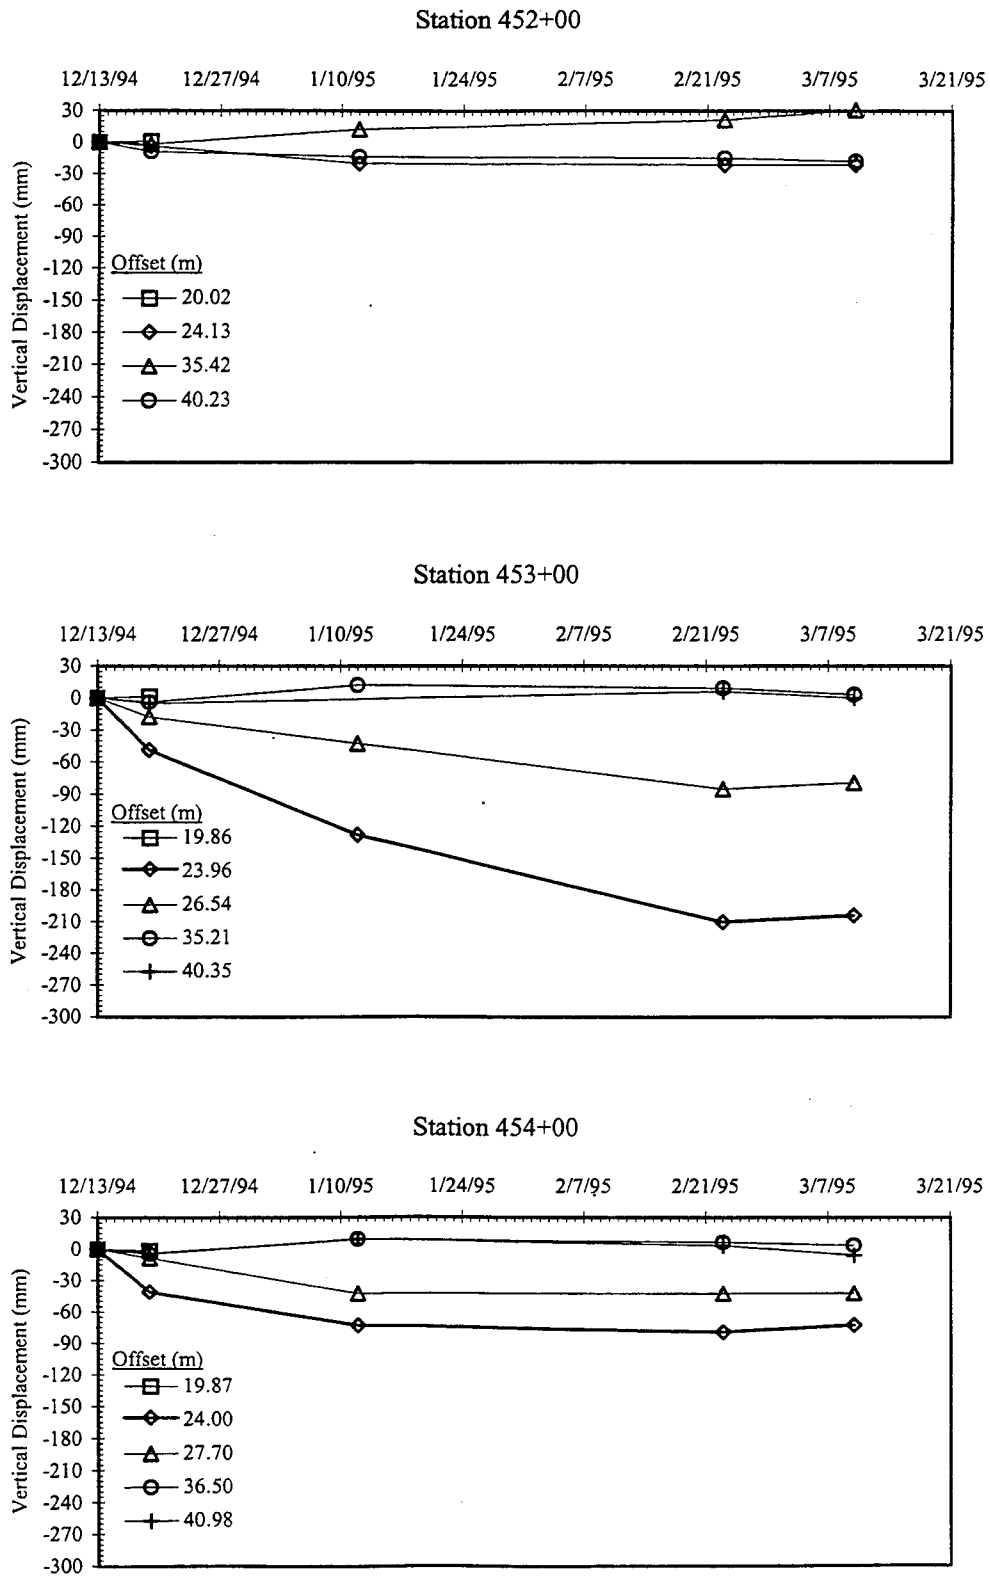
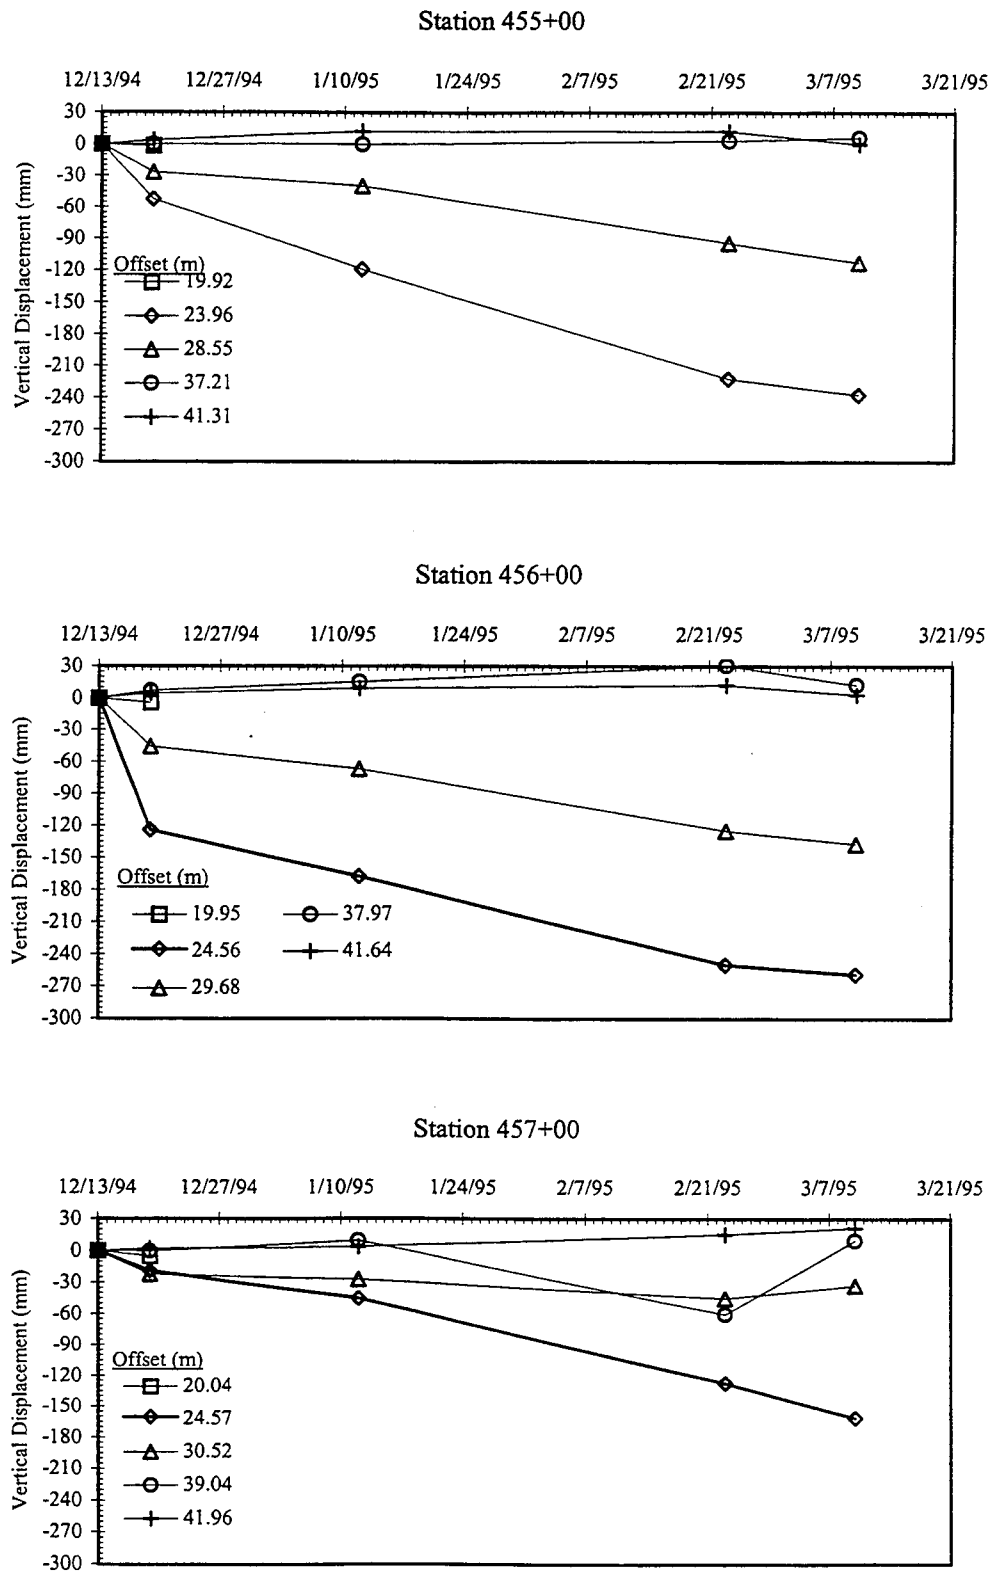
Figure 4.8. Vertical deformation data, I-69, Madison County, Greenfield District.

Vertical and horizontal deformation was measured by INDOT and is presented in Figures 4.8 and 4.9, respectively. Review of vertical deformation data reveals that the greatest settlement occurred in the sideslope, near the shoulder of the road and decreased with increasing distance from the centerline of I-69. No vertical displacement was noted at the toe of the embankment or beyond.

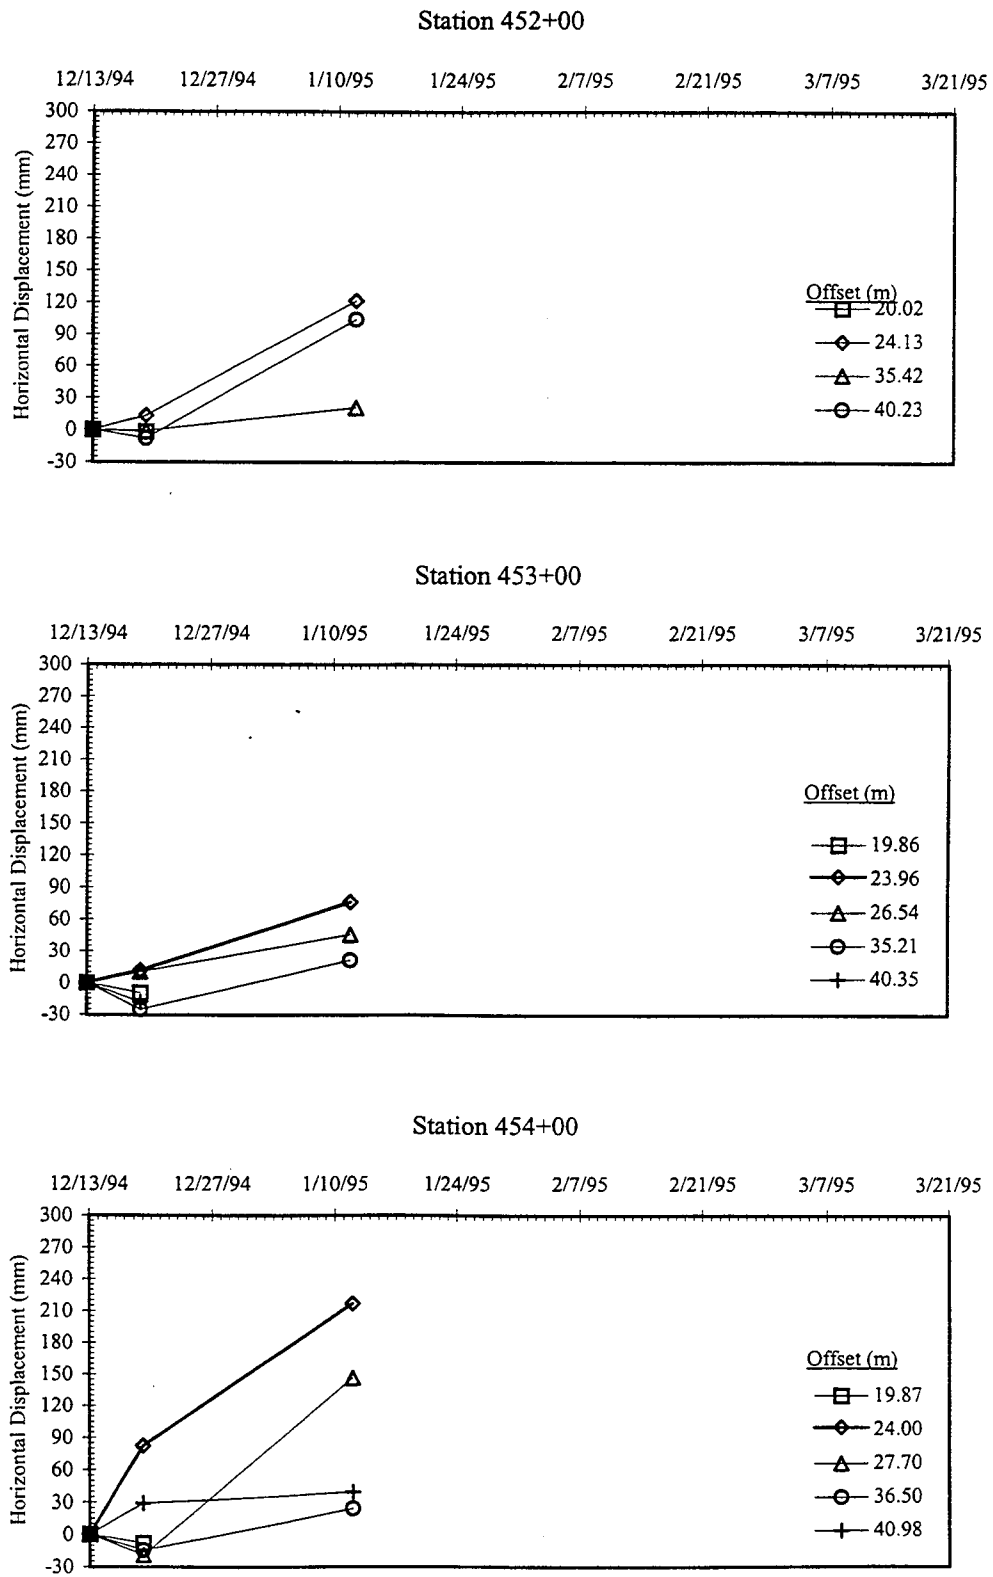
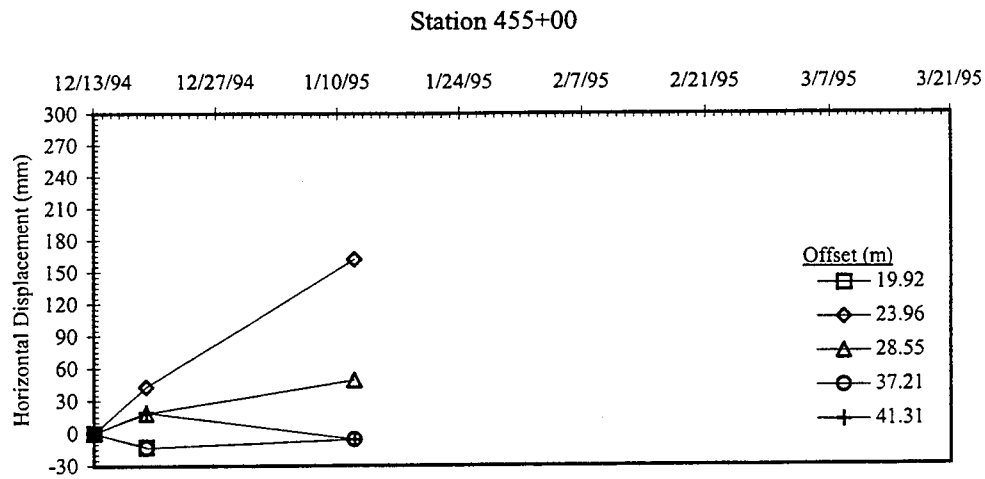
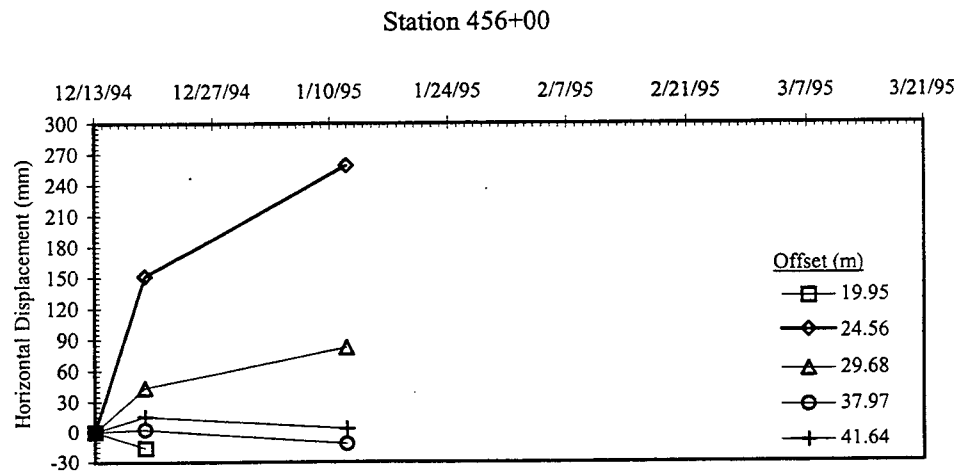
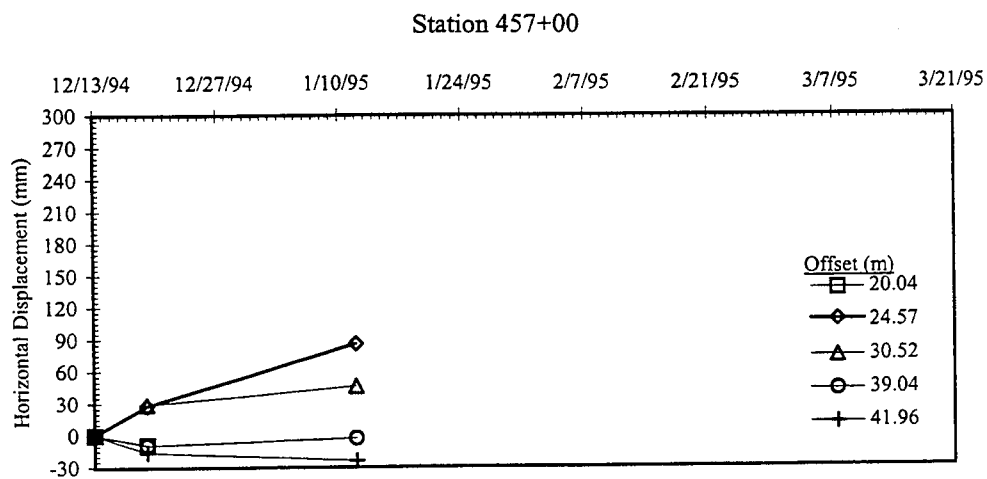
Figure 4.9. Horizontal deformation data, I-69, Madison County, Greenfield District.

Horizontal deformation data covers a relatively short time period. Aside from an anomalous reading at Sta. 452+00, no significant horizontal deformation was noted at the toe of the slope. Horizontal displacement at the crest was less than 300 mm for the time period considered.
